FOUNDATION CONDITIONS FOR PROPOSED DWELLINGS, NARARA ECOVILLAGE, LOTS 2 to 14; 16 to 35 and 40 to 48

This report provides design guidance on foundation conditions for proposed dwellings at Lots 2 to 14; 16 to 35 and 40 to 48¹ at the Ecovillage. This advice is based on specific investigations on these Lots following site works by Robeson's. It should be noted that previous investigations by Coffey Partner and by Douglas Partners focussed on the roadway, prior to these site works, and provided only generalised advice on building foundations, stating only that they should be in accordance with AS2870 and with standard 'good practice'.

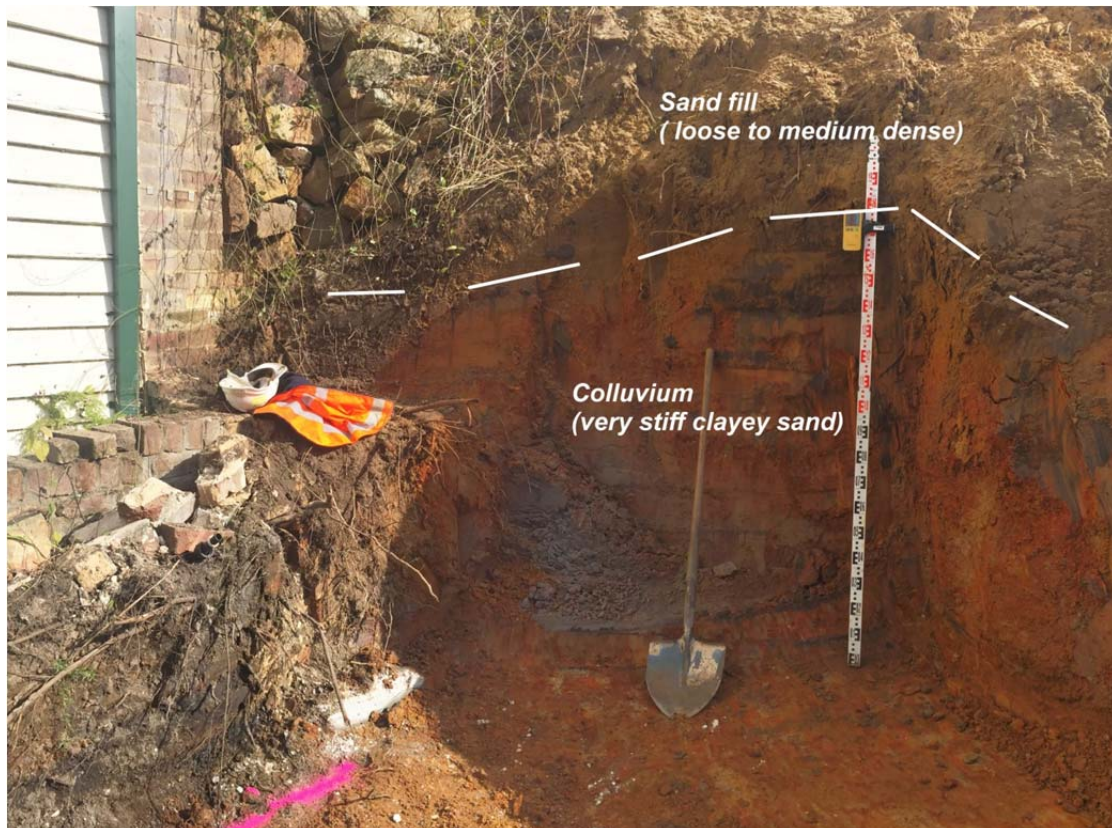
Photograph 1 – exposure of colluvium next to the Fisheries Building

The NEV site is underlain by the Terrigal Formation – comprising sandstone and siltstone. Natural residual soils (soil weathered insitu from the underlying rock) over the site typically comprise stiff to very stiff clay. The Lots in question are located on slopes of 10 to 15 degrees gradient. Loose weathered sandstone, derived from the regional Terrigal formation, and perhaps also uphill slopes of Hawkesbury sandstone, has historically fallen and deposited (i.e 'colluvium') at various locations over these slopes, and have weathered in-place to form another clayey horizon. This material may be described as ranging from Clayey Sand to Sandy Clay with extremely weathered sandstone gravel and cobbles (see Photographs 1 and 2 below). There is evidence of weak cementation by iron oxide. The colluvium has been referred to in test pit logs as 'slope-wash' – to indicate that its presence is not considered to be indicative from historical landslides or to give any indication of land instability. The site shows no evidence of transport by landslides. These natural clay materials (either slope wash or residual clays) are considered to be suitable founding materials, where they are at least 'stiff'. Typically, these colluvium or residual clay materials are found at shallow depths (less than 0.5 m) across the site.

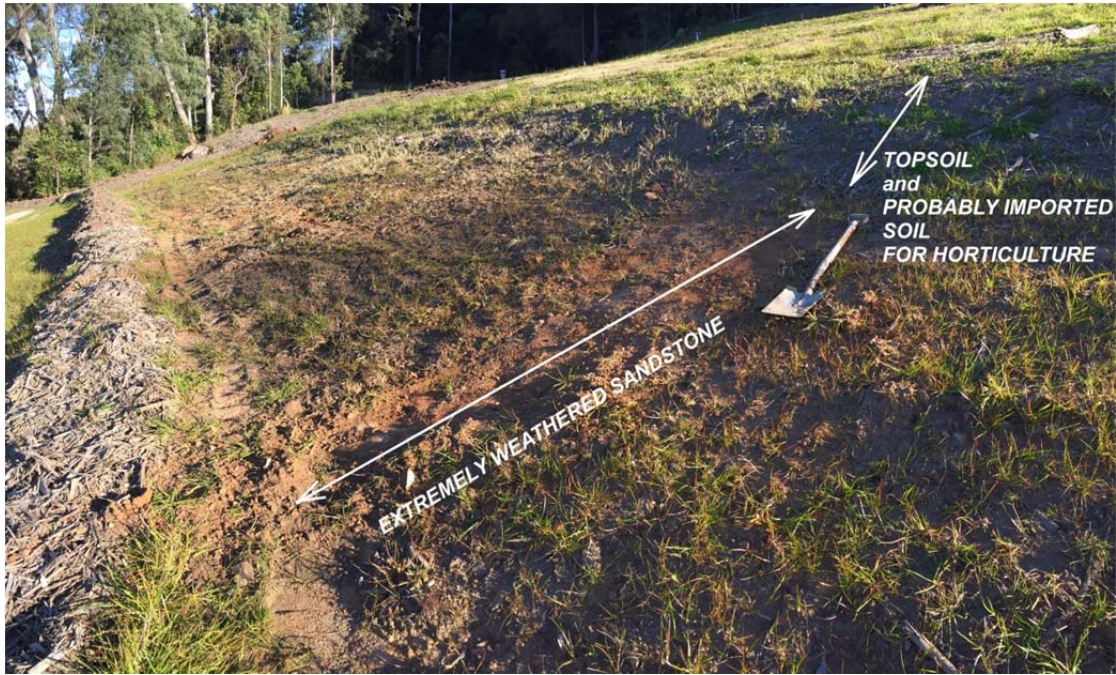
Photograph 2 – Outcrop of colluvium ‘slopewash’ (on Lot 32)

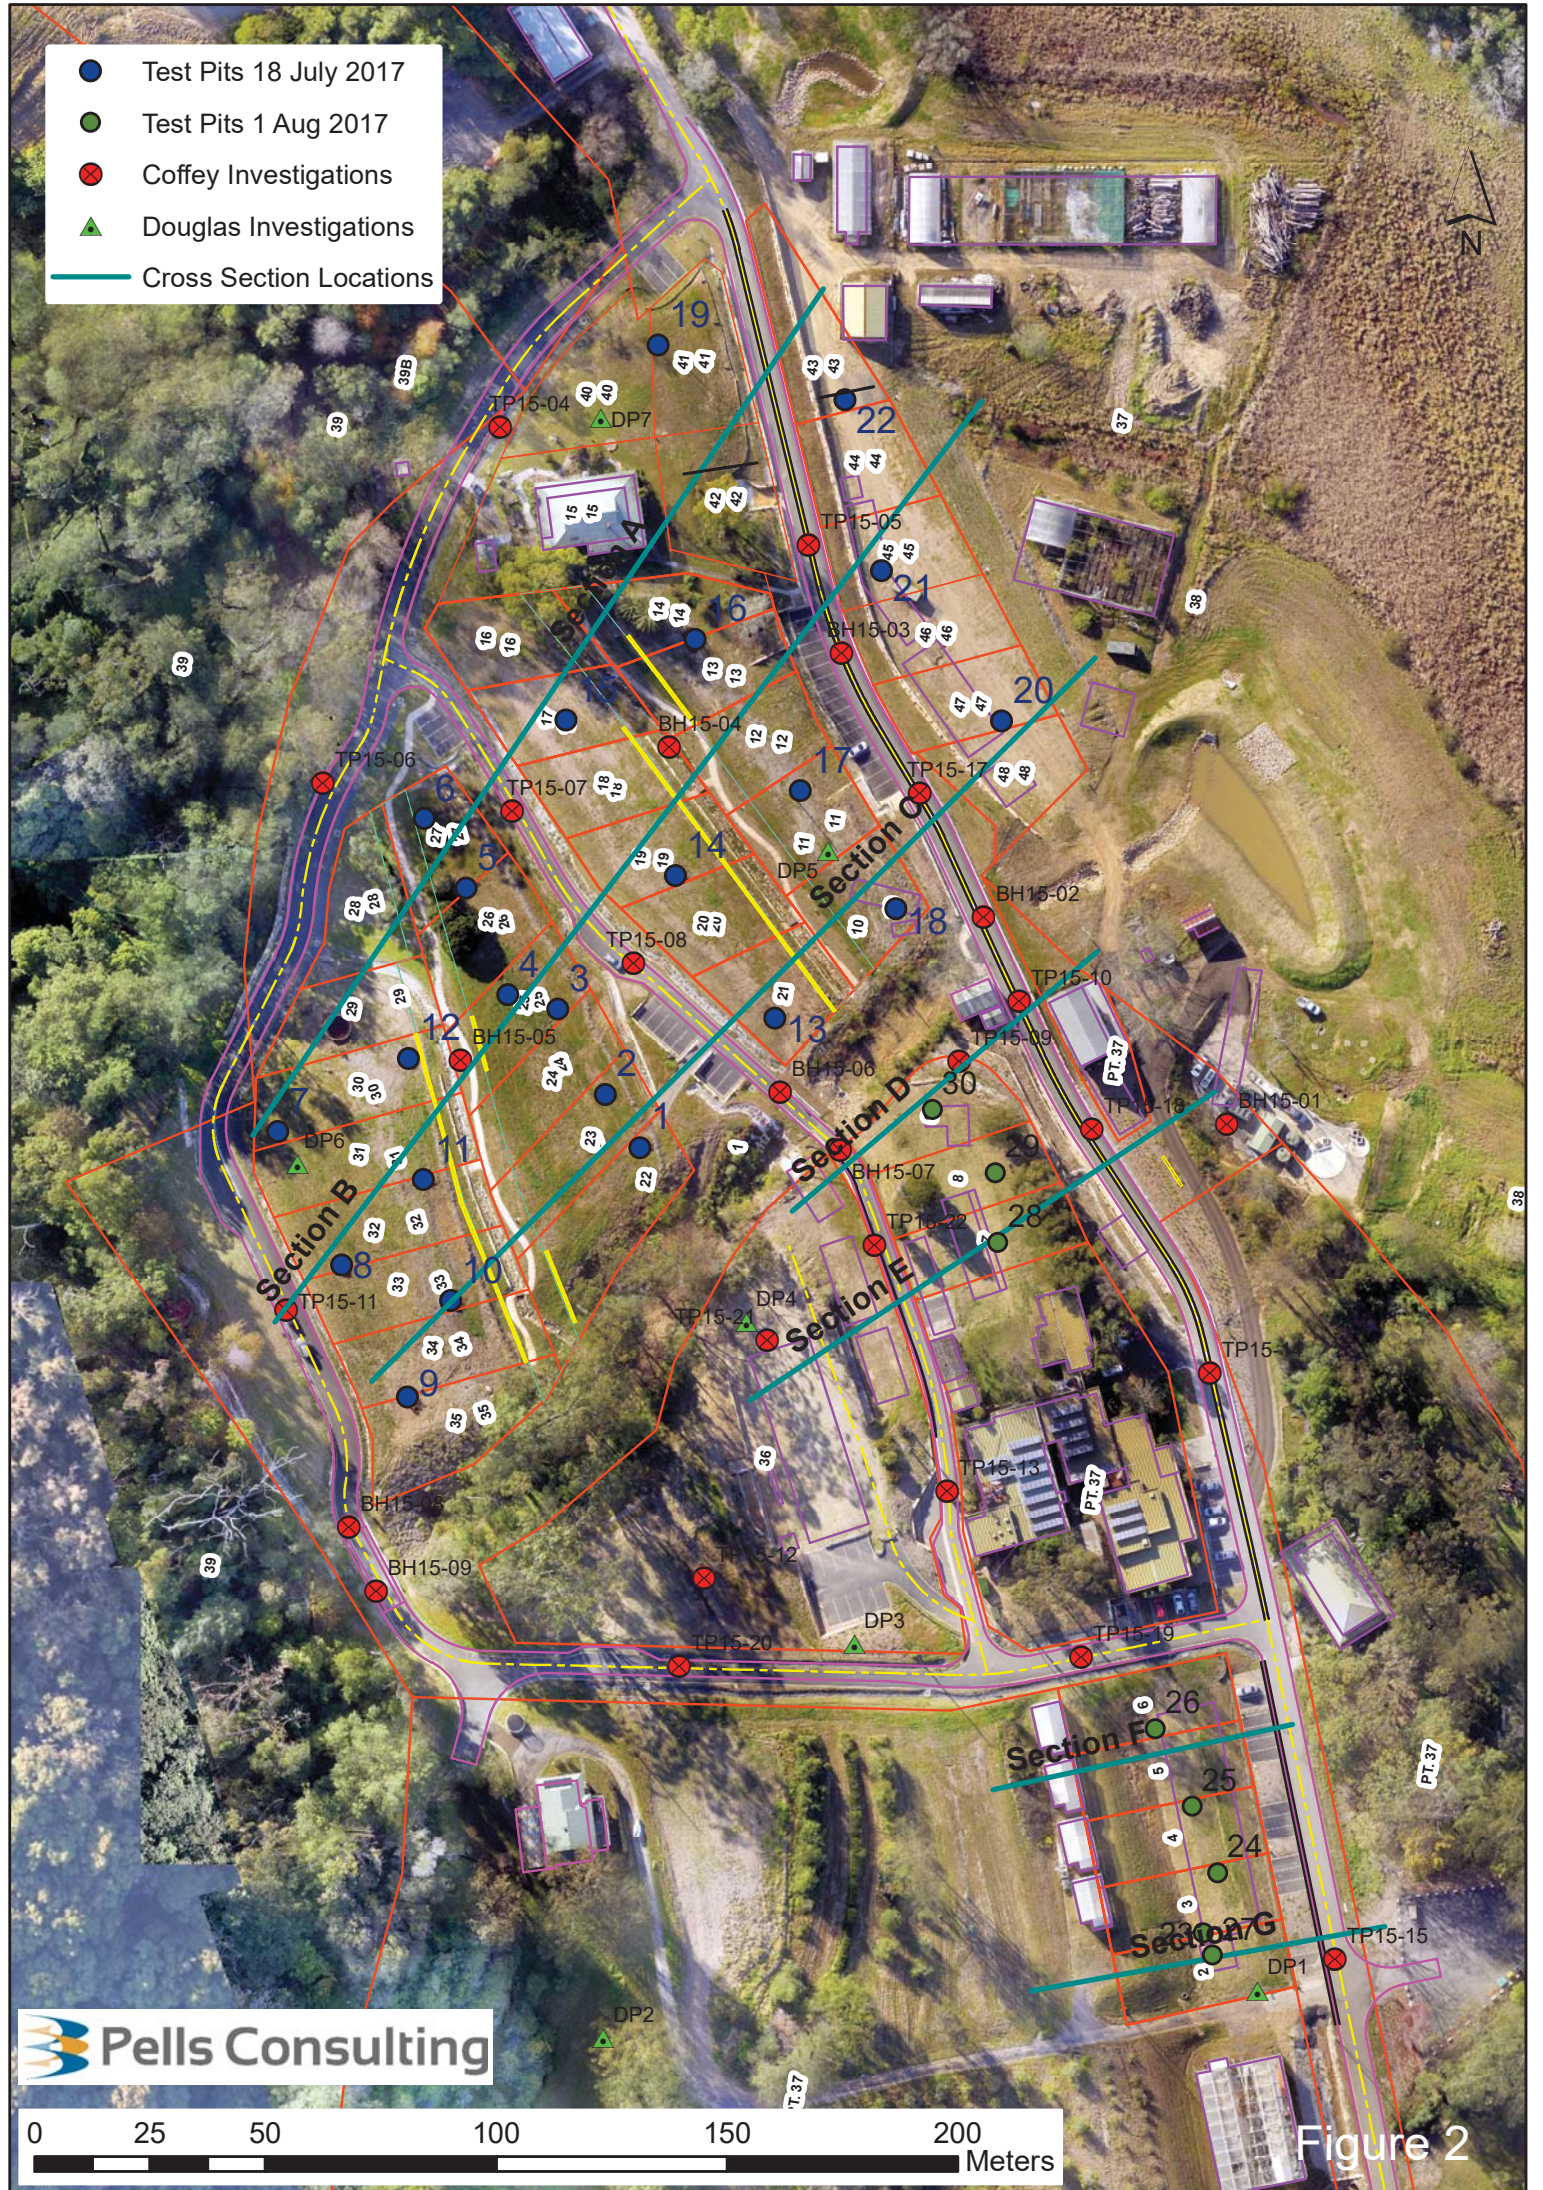
Figure 2

- Test Pits 1 Aug 2017
- Test Pits 18 July 2017
- ⊗ Coffey Investigations
- ▲ Douglas Investigations

The locations of investigations are shown in Figure 2. Figure 3 shows the same information, but superimposed on detailed topographic data obtained from the UAV survey. Figure 4 shows the assessed gradients across the site, again from UAV survey data. The seven cross sections locations are shown in Figure 3 to 4. Cross-sections are presented in Figures 5 to 11 respectively. Test pit logs are included in Appendix A of this report.

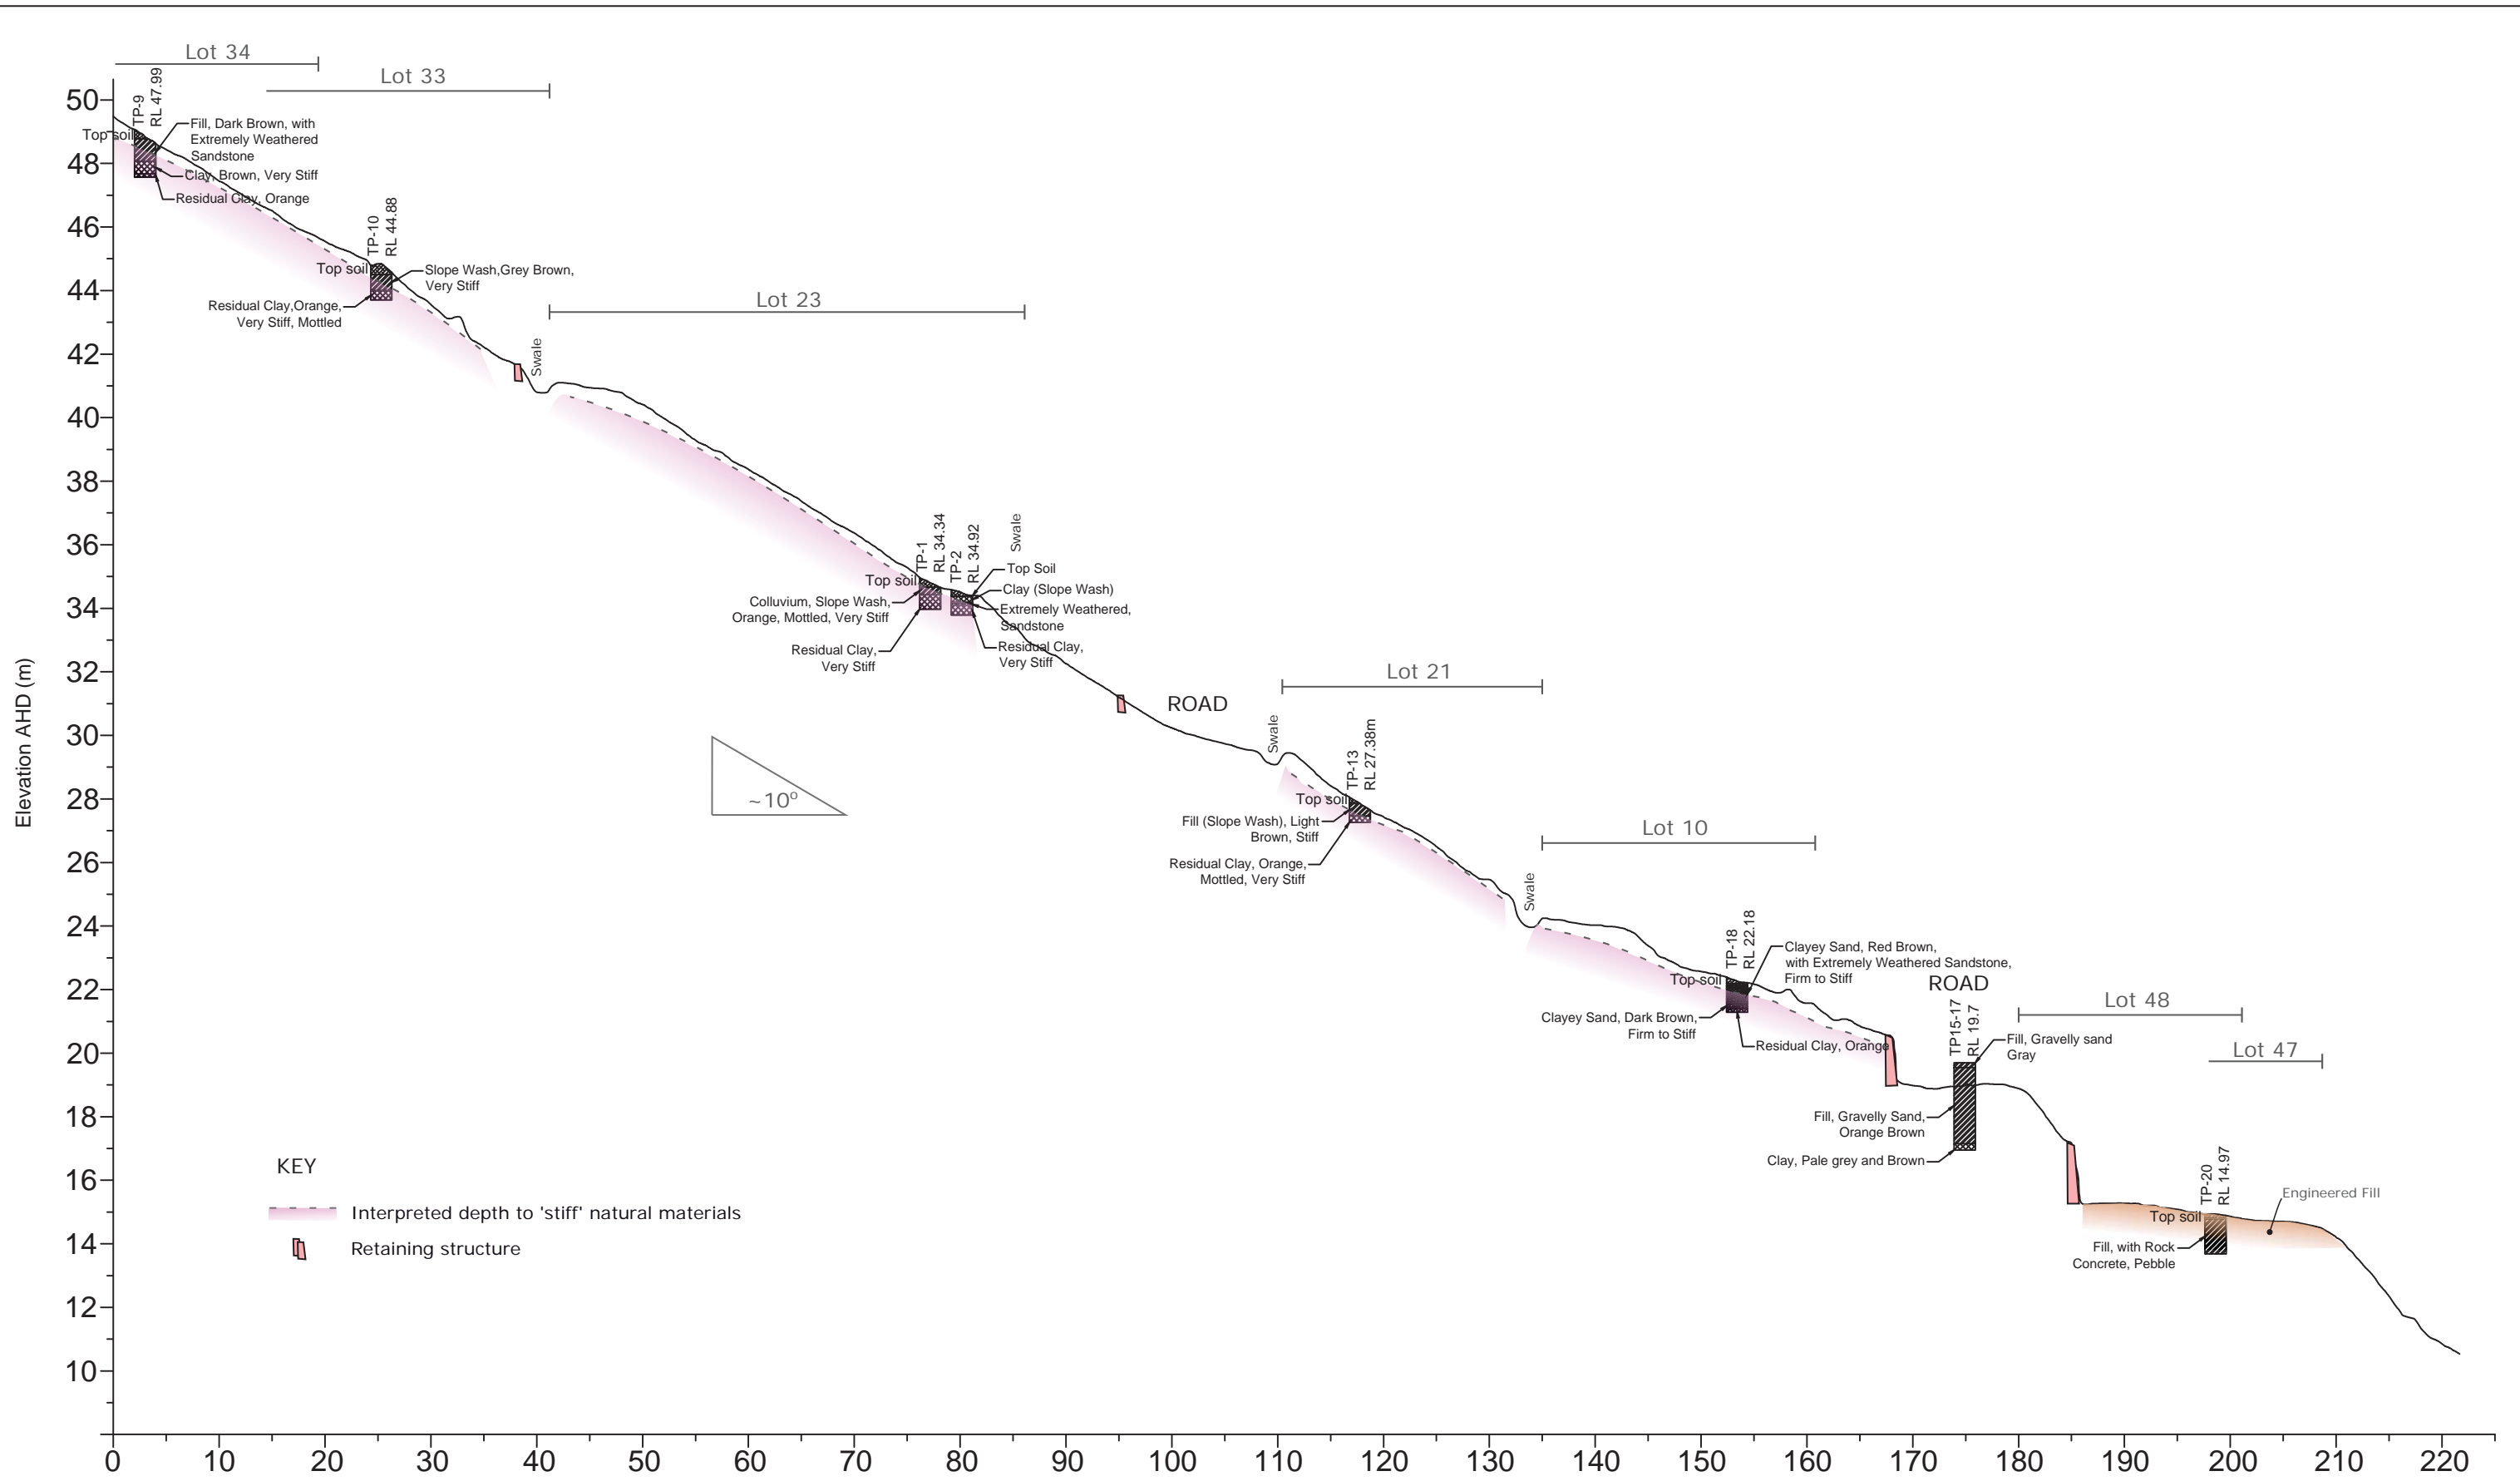
Figure 6

Section C
Exaggerated vertical scale H:V=1:3

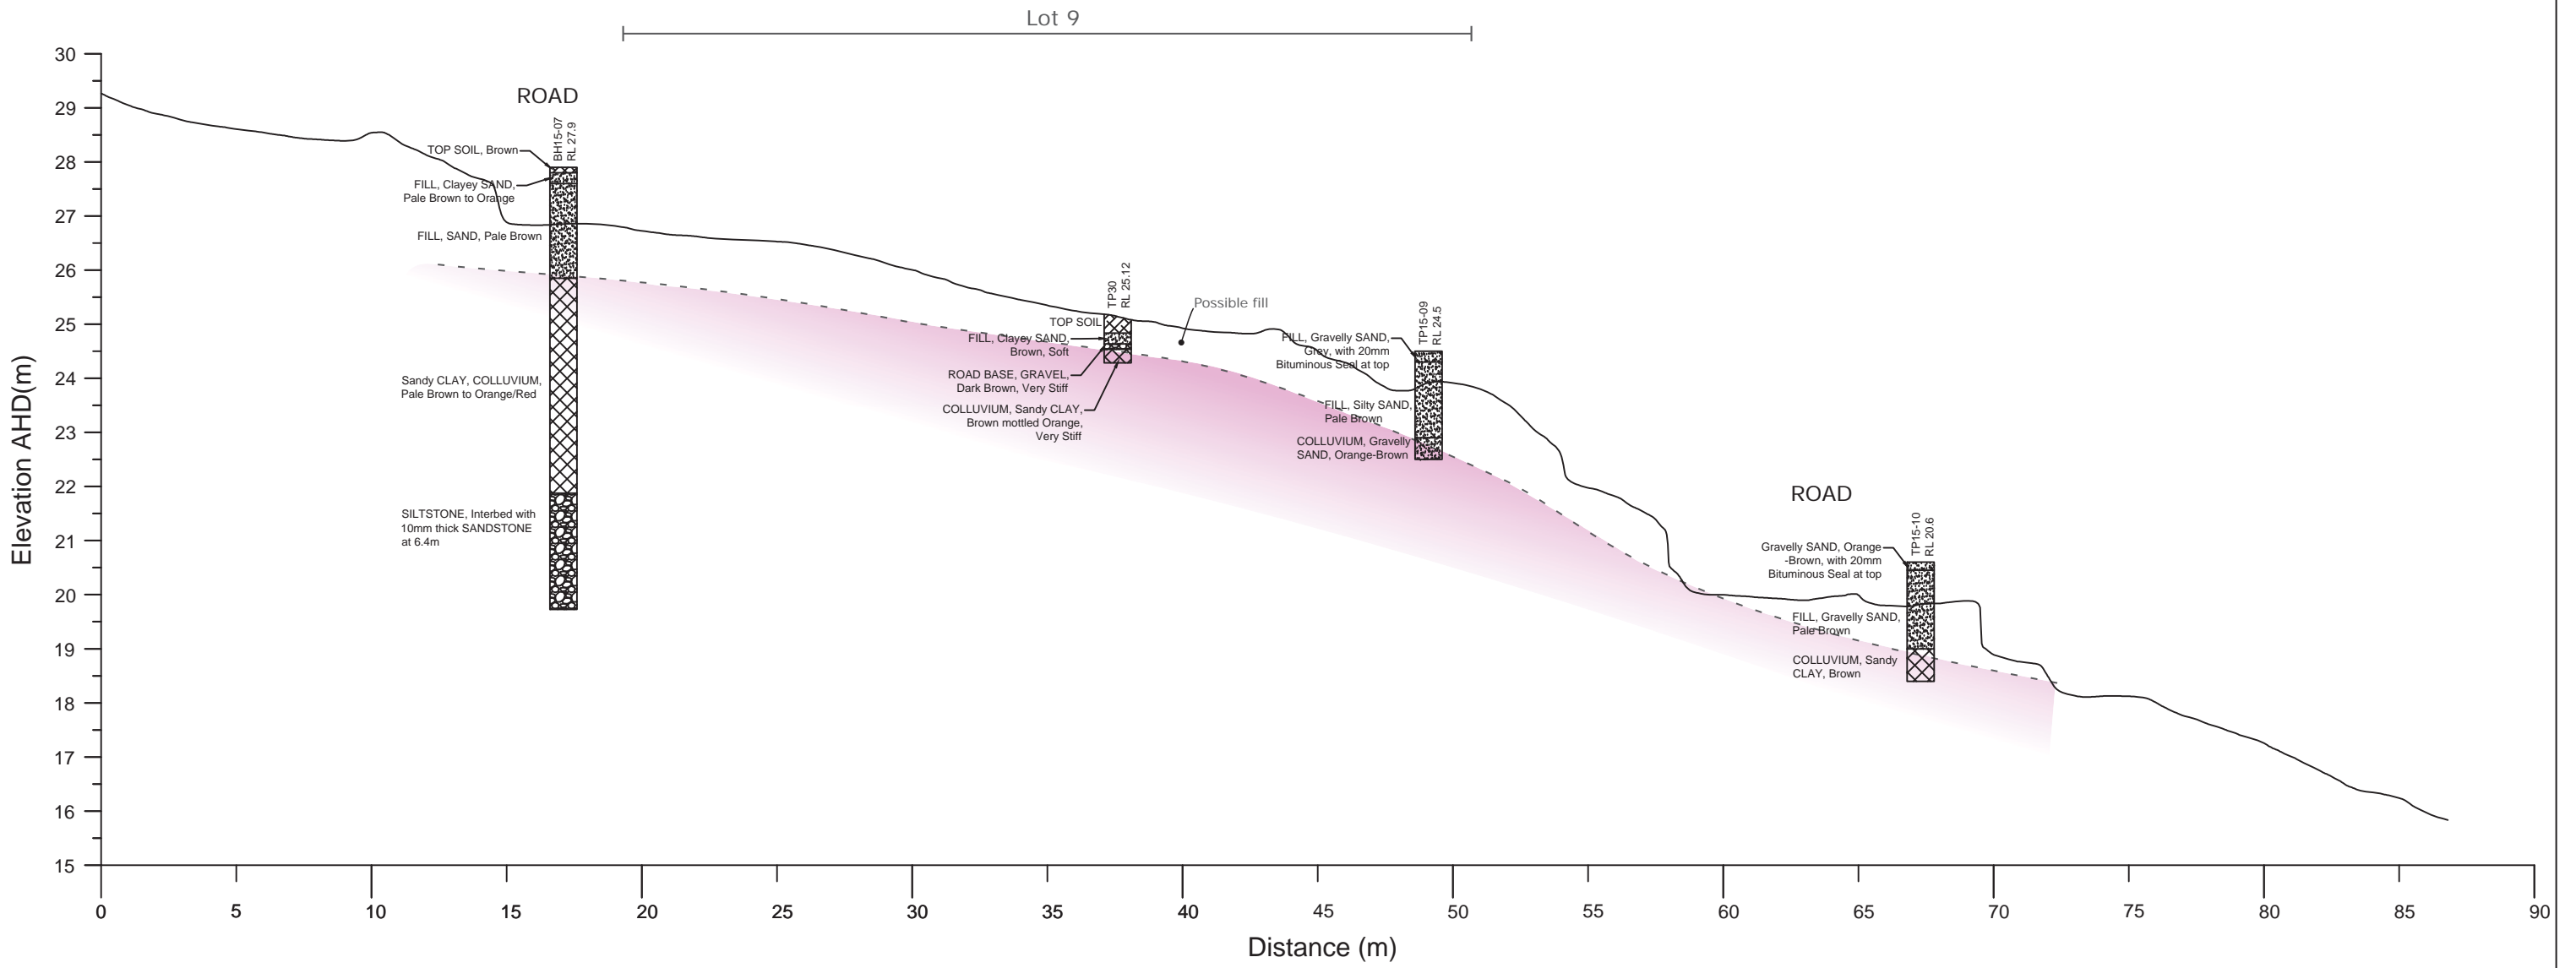
Figure 8

Section D

Exaggerated vertical scale H:V=1:2

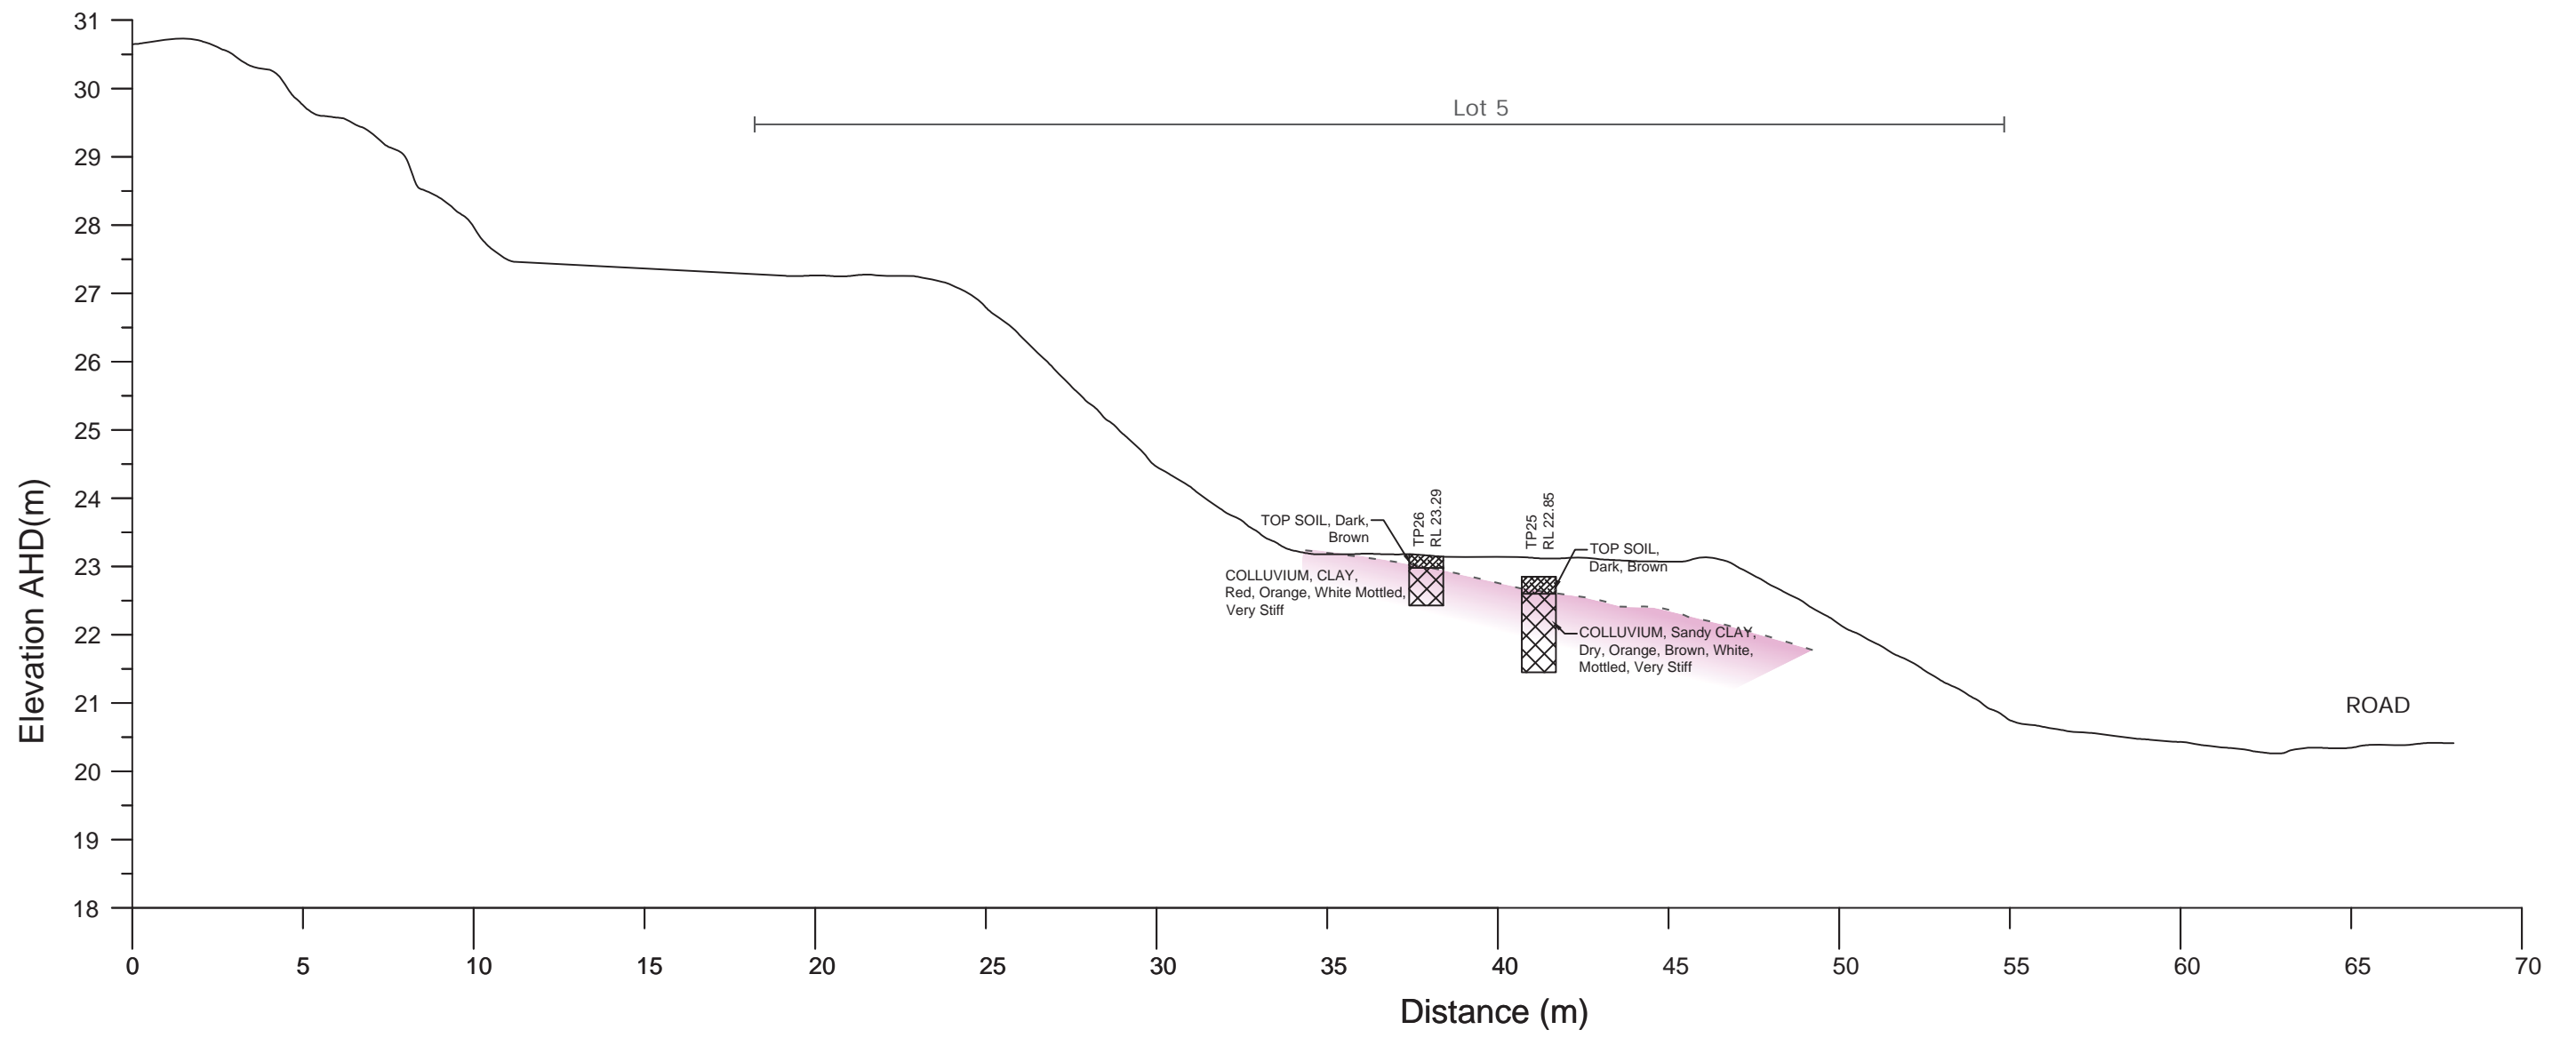
Figure 10

Section F

Exaggerated vertical scale H:V=1:2

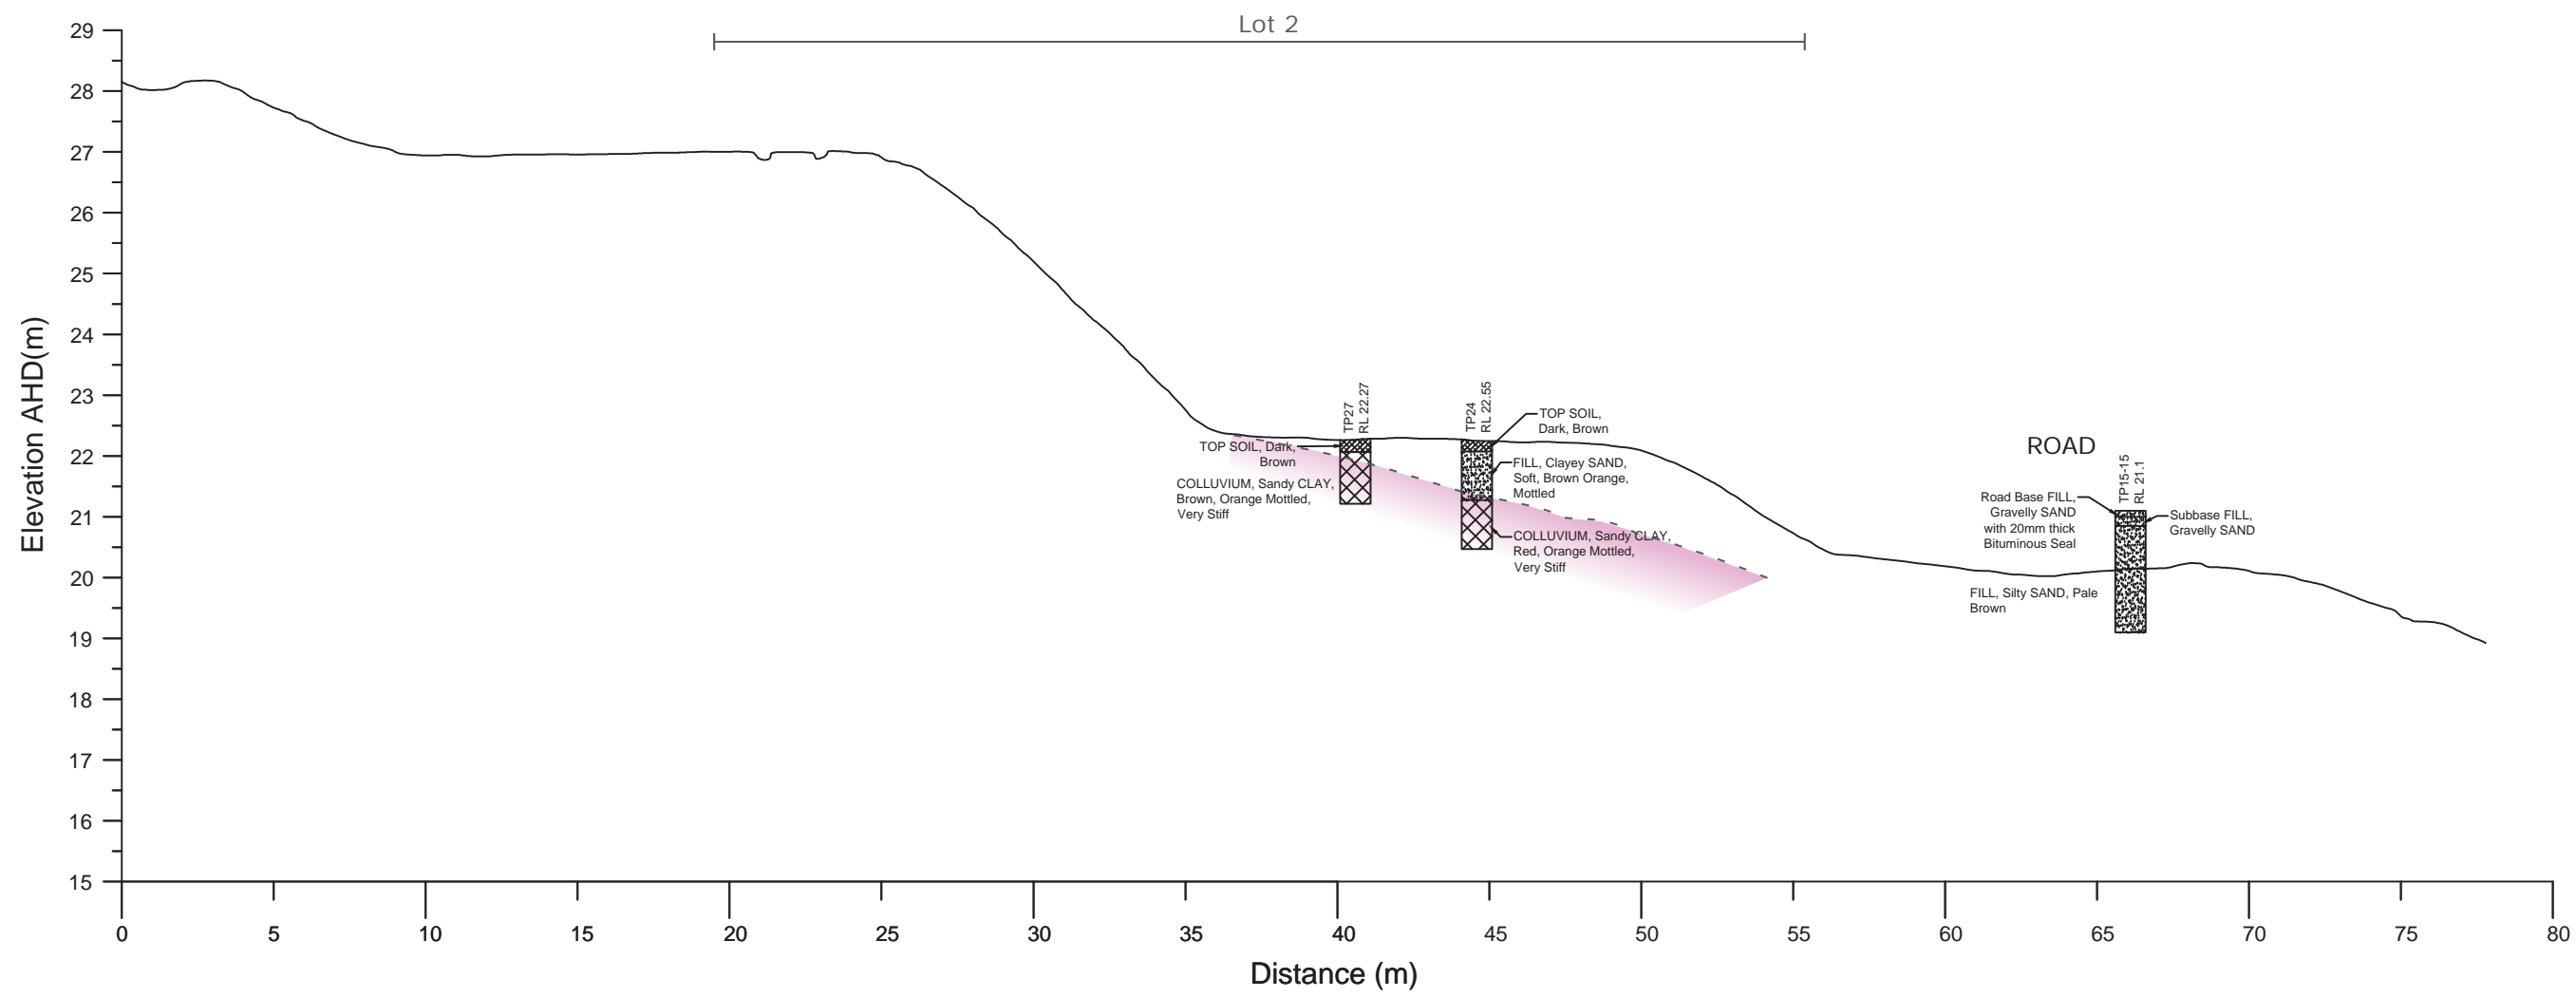
Figure 11

Section G

Exaggerated vertical scale H:V=1:2

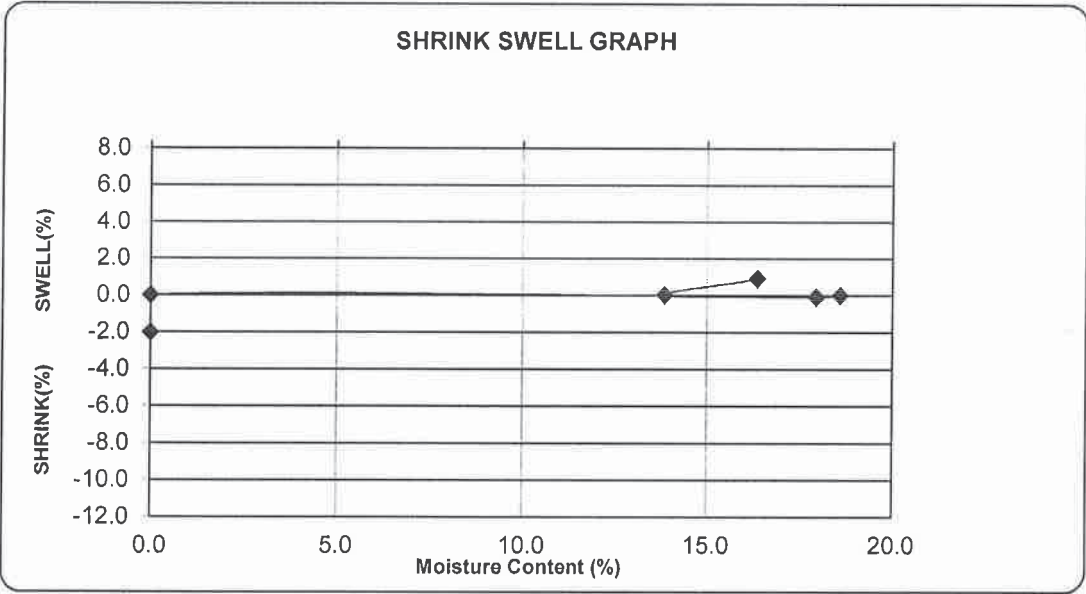
SHRINK SWELL GRAPH

SHRINK SWELL INDEX
1.38 %/pF

- Suction Value used in calculation = 1.8pF
- Volume Change Coefficient (α) was assumed = 2
- Inert Inclusions by volume = 0-5%
- Shrinkage Cracking = Moderate
- Soil Crumbling = none
- Date of receipt of sample: 24/07/2017. Sample supplied by client.

Shrink / swell testing on a sample of colluvium was undertaken, attached to this report, and demonstrated very low shrink / swell potential. This accords with previous testing for Lot 36 as reported in S027.L1.
